INTERPRETING THE PAST TO PROTECT THE FUTURE

*BRASS/El Pilar Program
1997 Field Report*

*ISBER/MesoAmerican Research Center
University of California - Santa Barbara
1997*

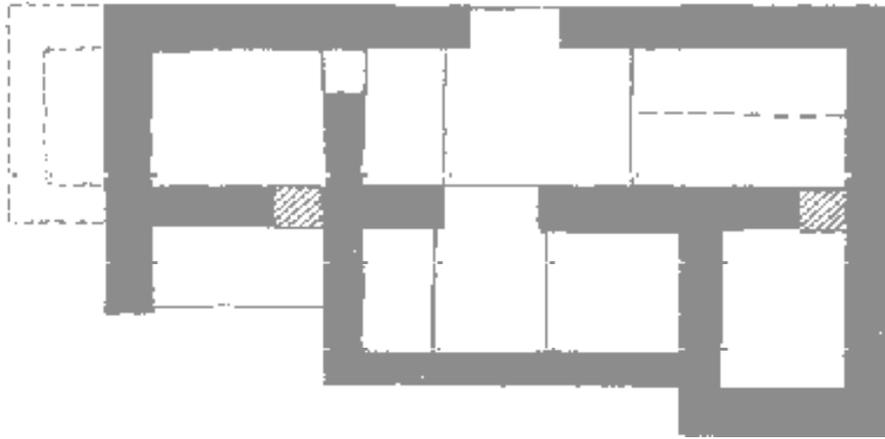
Figure 5: Str. 1 Schematic Plan

In summary, Str. 1 of the Tzunu'un group was a complex and imposing building defined by a structure two tiers wide and divided into five rooms. Situated on the south

edge of a plaza, its base is about one meter above the plaza level. Excavation revealed that the building evolved with incremental interior modifications to attain its final floor plan (Fig. 5). The artifacts recovered from Str. 1 included obsidian prismatic blades, a decorated spindle whorl, utilitarian and decorated ceramic sherds, parts of manos and metates, chert bifaces, as well as chert flakes and other lithic debris. The array is in keeping with materials associated with residential architecture.

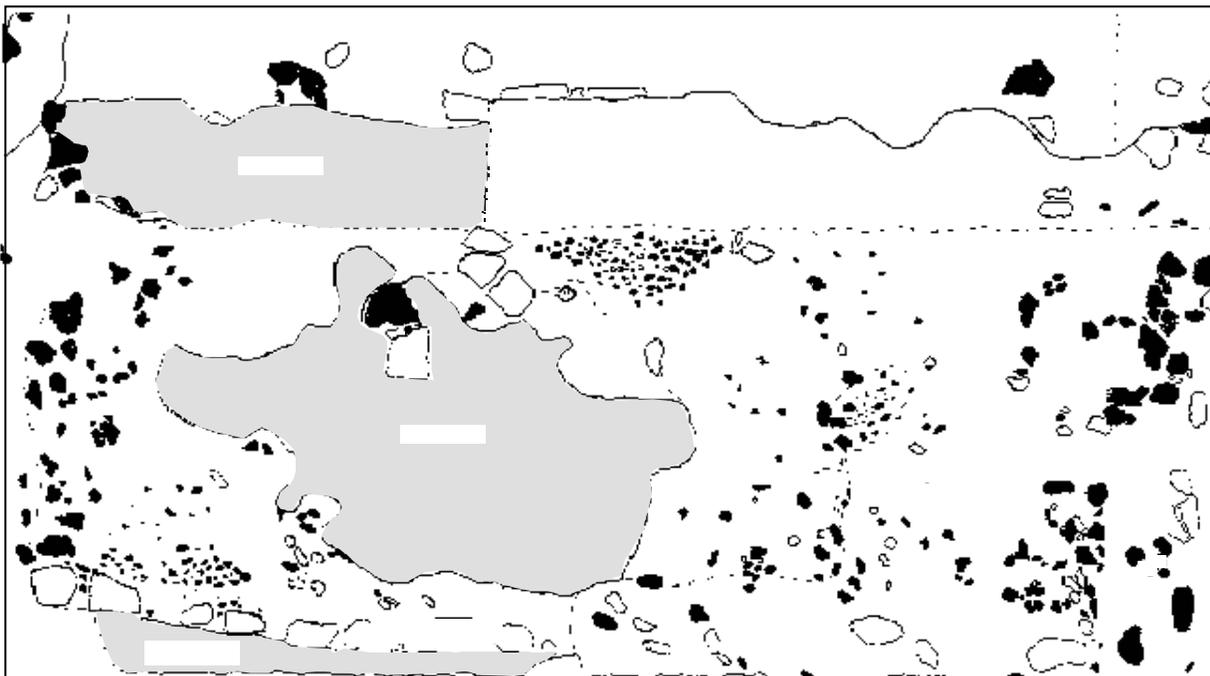
Figure 6: Str. 3 Excavation Plan

Structure 3: Directly north of the imposing Str 1 is Str. 3, a low construction defining the plaza edge and distinguishable as a c. 60 cm mound above the plaza level (Fig. 6). Excavations began with the removal of the humus layer [3-01]. Directly underlying the humus layer were the remains of a plaster floor [(FL)3-02]. This floor was in good condition, considering its proximity to the surface. To the south, however, the floor preservation

deteriorated as it approached a limestone block wall [(WL)3-03] that demarked the front of the structure. Outside and contiguous to this south wall [(WL) 3-03] was another plaster floor [(FL)3-04]. This floor was encountered in relatively poor condition, was at a lower level than the interior floor, and may represent the courtyard plaza surface.

Excavations of the 2 x 2 meter grid proceeded from west to east. In the center of Str. 3, a deposit of nine human teeth [(BU)3-05] was located beneath several large unshaped limestone rocks. It is not known if the deposit represents one individual or several; there was little evidence of wear on all the teeth and no artifacts associated with the deposit. To the east below the deteriorated interior floor surface [(FL) 3-02] a compressed limestone cobble and gravel fill [3-07] was revealed and interpreted as a subfloor. This fill [3-07] disintegrates into a rough, uneven edge on the far east and north side of the structure.

On the north edge of Str. 3, underlying the humus and fill layer, was another well preserved plaster floor [(FL) 3-09]. This floor [(FL) 3-09] represents an earlier construction phase, as it is 65 cm below the surface floor [(FL) 3-04]. This floor may be part of an earlier structure or related to an early phase of the plaza construction. The excavated remains of Str. 3, with the intact interior plaster floor, supports an interpretation of a perishable superstructure enclosing a living area.

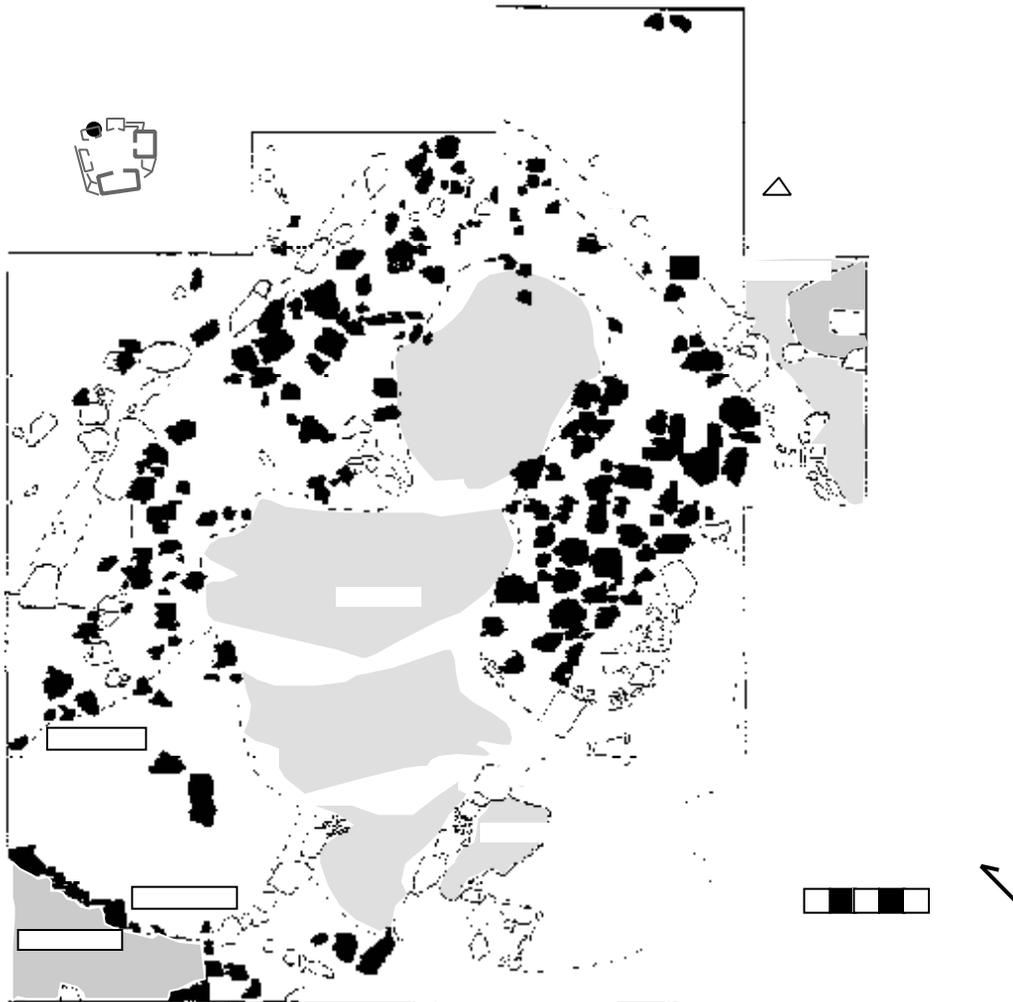
Figure 7: Str. 4 Excavation Plan

Structure 4: Continuing around the raised courtyard to the west is Str 4. This structure is a distinct mound situated on the northwestern corner of the plaza (Fig. 7). As the excavations removed the humus layer [4-01], the first noticeable feature was the unusual distribution of chert cobbles and boulders. The presence of this chert feature was deemed relevant to the construction and was left in situ. It became apparent that these chert boulders were located in the interior and eastern portion of the building and represented a diagnostic aspect of Str. 4.

Excavation in the western side of the mound revealed a portion of a deteriorated plaster floor [(FL)4-02]. The floor was in poor condition and only small parts of it remained intact. Exposures also uncovered the structure's walls. The south wall [(WL)4-03], east wall [(WL)4-07], and north wall [(WL)4-08] were made of uniformly shaped limestone blocks that probably served as a foundation for perishable walls. The large trees growing on the western side of the mound may, in part, account for the scant evidence of the west wall of this building.

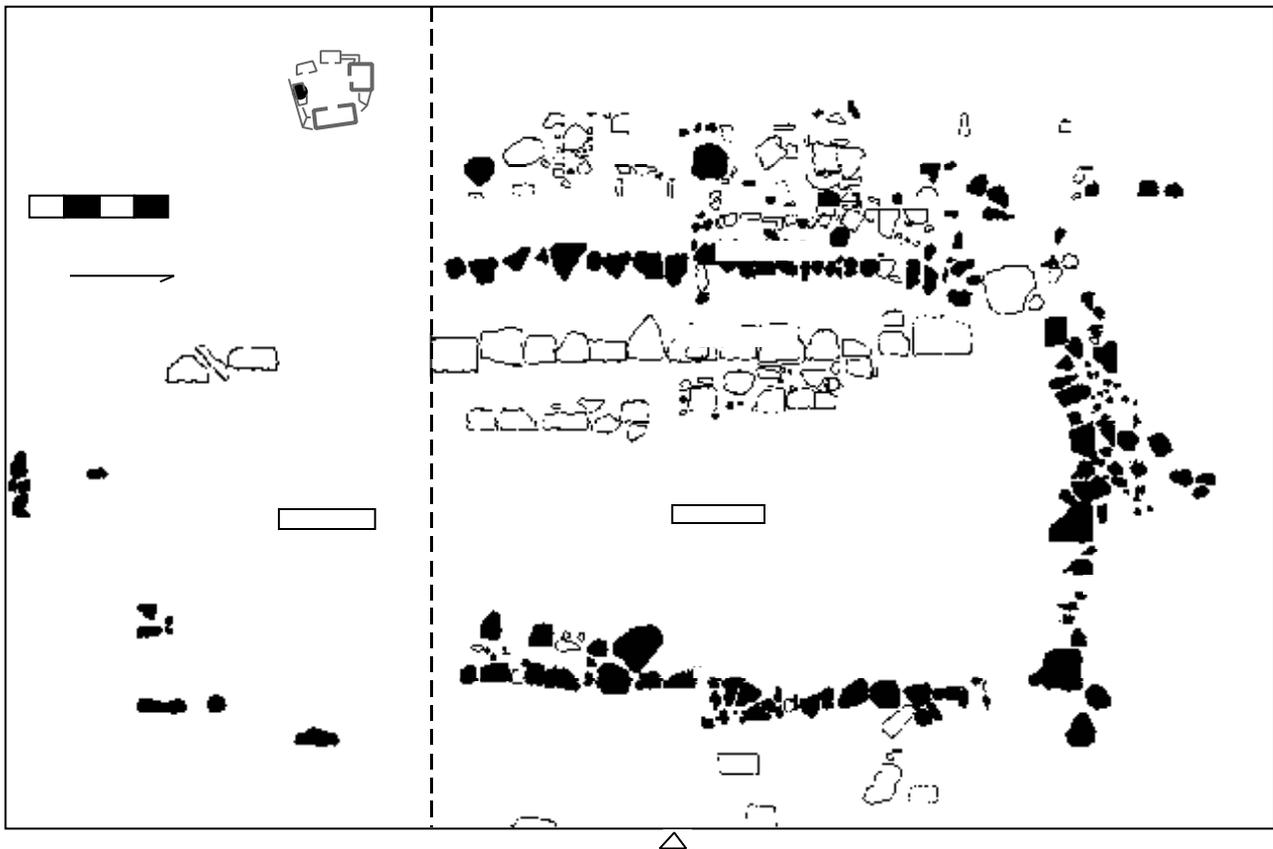
Figure 8: Str. 5 Excavation Plan

In the very beginning of the investigation, a burial [(BU)5-02] was located near the center of the mound, immediately below the humus. Excavation of the burial revealed an adult skeleton (possibly female) positioned face up, but flexed with the head to the south. This interment was located adjacent to the east and inside of a wall [(WL)5-06]. The soil matrix around the individual included a large number of ceramic sherds and lithic debitage and was retained for later flotation analysis.

After this burial was removed, we were able to delimit the extent of the northern portion of Str. 5. As with Str. 3 and Str. 4, stone foundations were encountered that defined the structure boundaries and suggest the existence of a perishable superstructure. The east and north limits of the building were marked by chert cobble walls [(WL)5-05 and (WL)5-08] that ran north-south and east-west, respectively. The western limit was defined by a north-south limestone block wall [(WL)5-06]. A thick (c. 50cm) limestone/chert gravel fill with very little soil [5-04] was defined as a subfloor between the east wall [(WL)5-05] and the west wall [(WL)5-06]. This fill contained a very high quantity of size sorted ceramic sherds and chert debitage. Several pieces of obsidian prismatic blades were also recovered from this fill. On the far west side of Str. 5, an outer north-south chert cobble wall [(WL) 5-07] was encountered that appears to be a retaining or platform wall for the building and plaza.

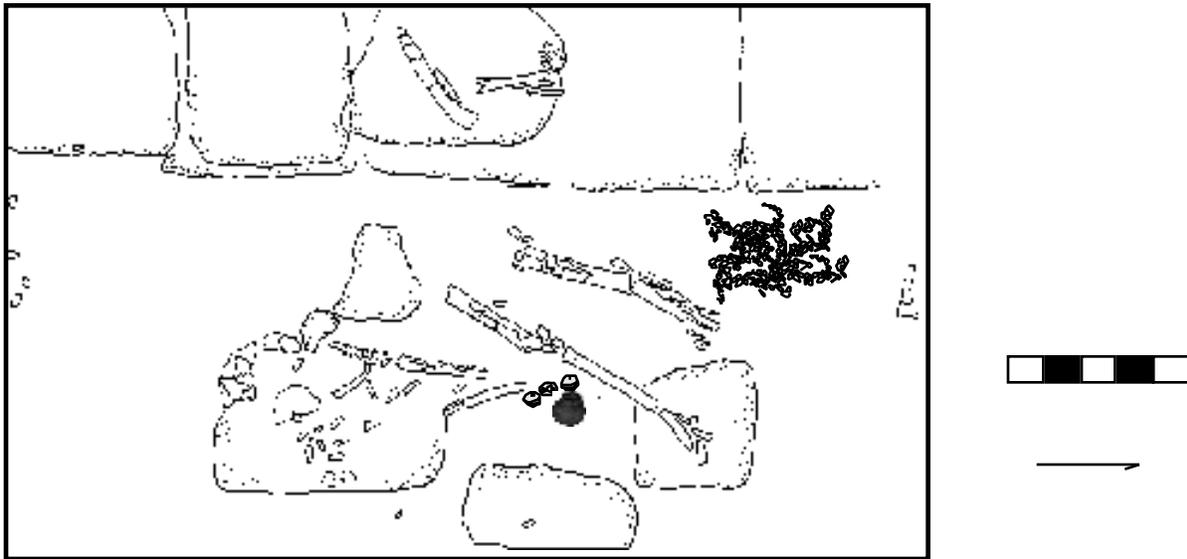
Figure 9: Str. 5 Burial Plan

The skeletal preservation was poor, consisting mainly of portions of long bones, several teeth, fragments of mandible, and small bits of the cranium (Fig. 9). Burial goods included one complete miniature jar, 287 small marine olive shells with irregularly drilled

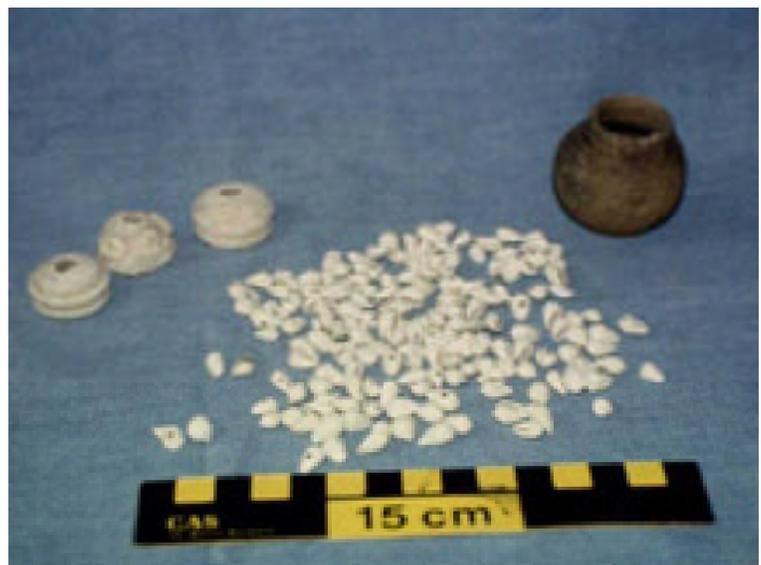
Figure 10: Str. 5 Artifacts Associated with Burial

holes, and three decorated limestone spindle whorls (Fig. 10). The shells were located on the northwestern side of the skeleton and were possibly attached to a garment or cloth, while the jar and spindle whorls were deposited on the northeastern side.

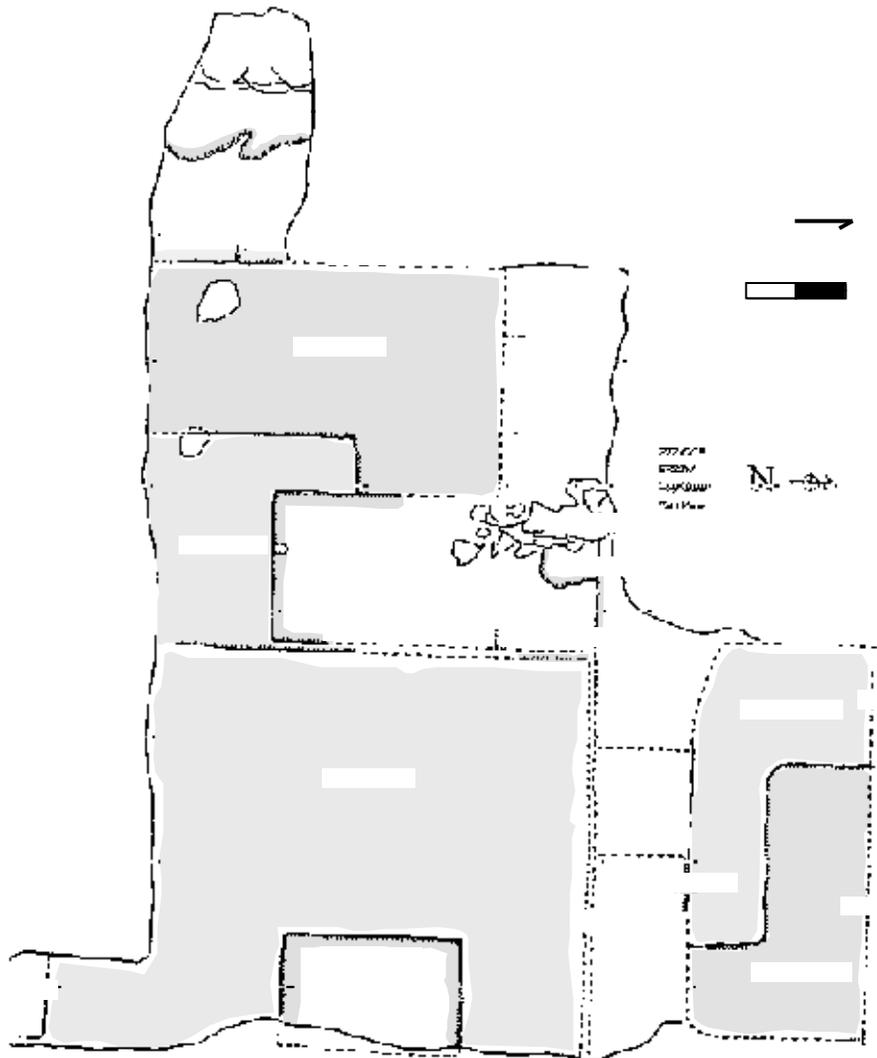
Figure 11: Room Plan in North West Section of Plaza Jobo

Plaza Jobo is a relatively small enclosed plaza located in the southwest corner of the H'mena, the highest elevation of civic-ceremonial monuments at El Pilar. Excavations in the northwest corner of Plaza Jobo in 1996, in and around structure EP22W, revealed well-preserved constructions along the west end of the plaza, defined as EP53, as well as a substantial plaster floor that runs continuously across the 3 exposed rooms of two numbered structures (EP22 and EP53) enclosing the northwest corner of the plaza (Fig. 11).

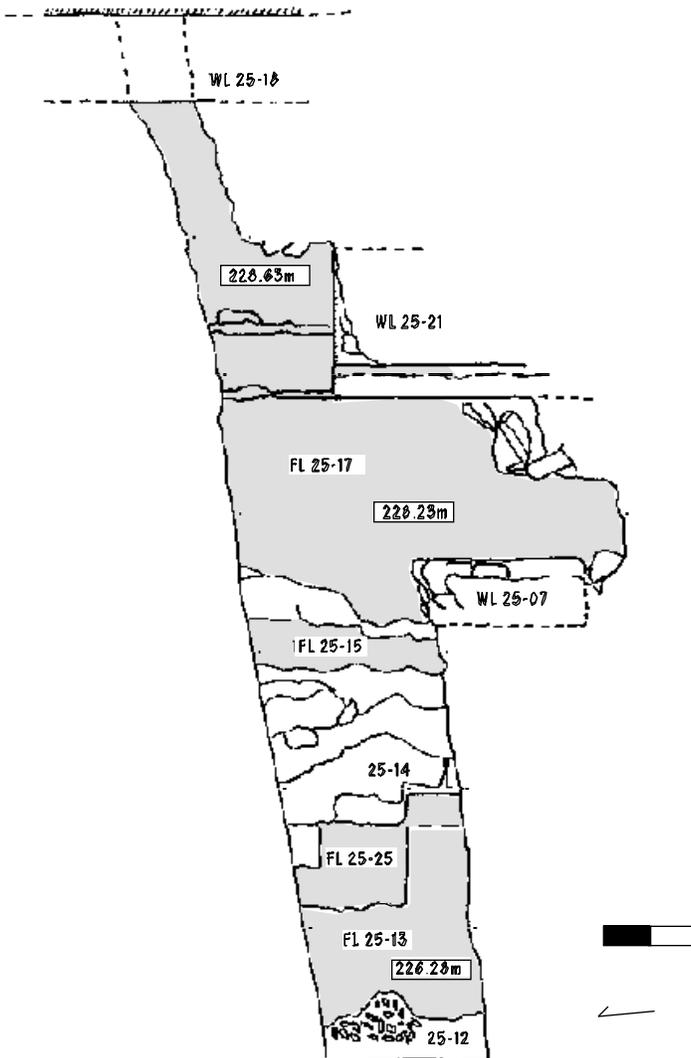
Figure 13: Xamanaj Temple Excavation Plan

Excavation began with the clearing of the axial looters' trench (Fig. 13). This excavation exposed an excellent plaster floor on the platform of the structure as well as two well-preserved plaster steps between the two front rooms located west of the vaulted room. A 7 x 11 meter trench extension was designed to examine the condition of the front steps of the structure and their contact with Plaza Lec. The excavation quickly revealed the plaster and the gravel ballast of Plaza Lec as well as what has been determined to be the stone and lime cement base for part of the EP25 steps. A small 1 x 1 meter probe to the south of the looters' trench at the location of the interior steps uncovered the door jamb between the front and middle rooms of the temple. The facade includes a substantial battered basal wall [(WL)25-21] adjacent to the interior step.

From these excavations associated with the looters trench, EP25 was evidently originally constructed as a two-room vaulted structure facing west with a large outer wall and a battered basal molding [(WL)25-21]. At a later point in time, after a burning event on the platform which left a layer of ash and debris [25-24] within the original front door jamb (between the middle and front rooms), the steps were covered over by a layer of well-packed limestone marl [25-23]. This appears to convert the two steps of the interior building platform into a ramp.

The west wall [(WL)25-01], defining a third, outer or front room was part of an addition to the west and was built with stonework inferior to that of the original two-room structure. The collapse debris between the facade of the original structure [(WL)25-21] and this final west wall [(WL)25-01] show that this space was once vaulted as well. The final west wall was built on the edge of the temple platform which has badly deteriorated and much of its western face has collapsed down the front of the structure. The information gathered to date makes it difficult to say whether or not there was a central doorway in this west wall or if the gap is the result of the looters who simply smashed through the wall area with their trench. It is clear, however, that the latest composition of the temple had three rooms accessed by a stair on the west, facing on to Plaza Lec.

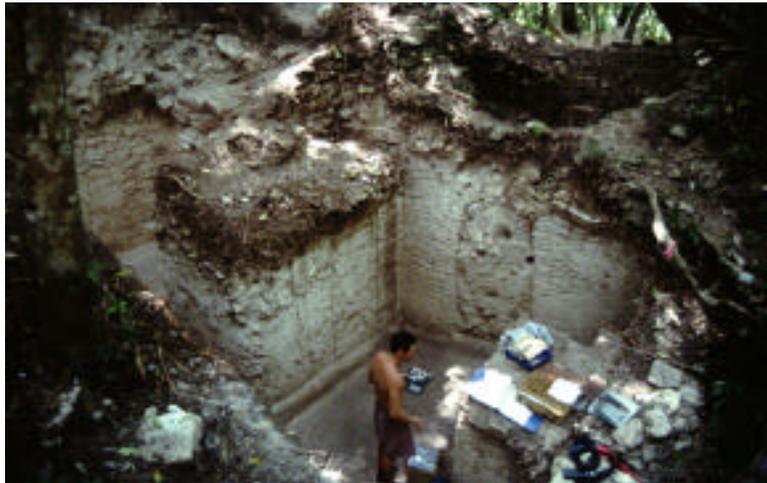
Figure 15: Plaza Jobo During Excavation

the 1996 season to maintain the stones and vault in place (Fig. 15). The conservators carefully repointed these walls [(WL)22-08, (WL)22-04, (WL)22-09] before excavating the central doorway and rebuilding the doorway (Fig. 16).

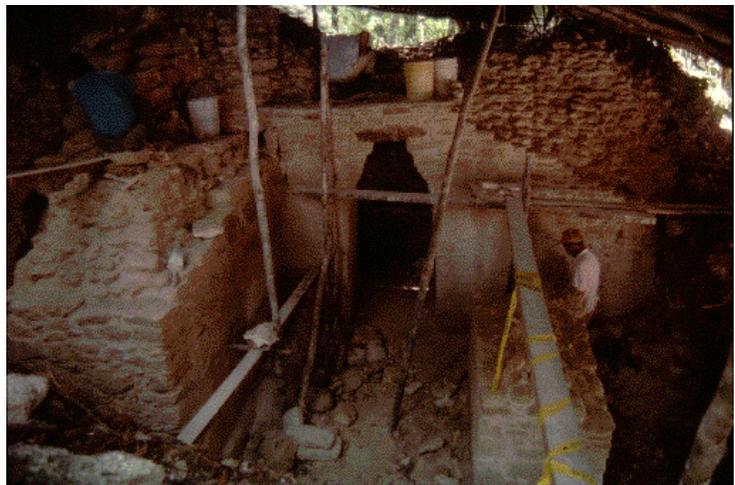
Figure 16: Plaza Jobo During Consolidation

This laborious process rescued one original capstone in situ. The degraded remains of the other two capstones were replaced with suitable matching stones. By the completion of the field season this door, closed for some thousand years, was once again open (Fig. 17).

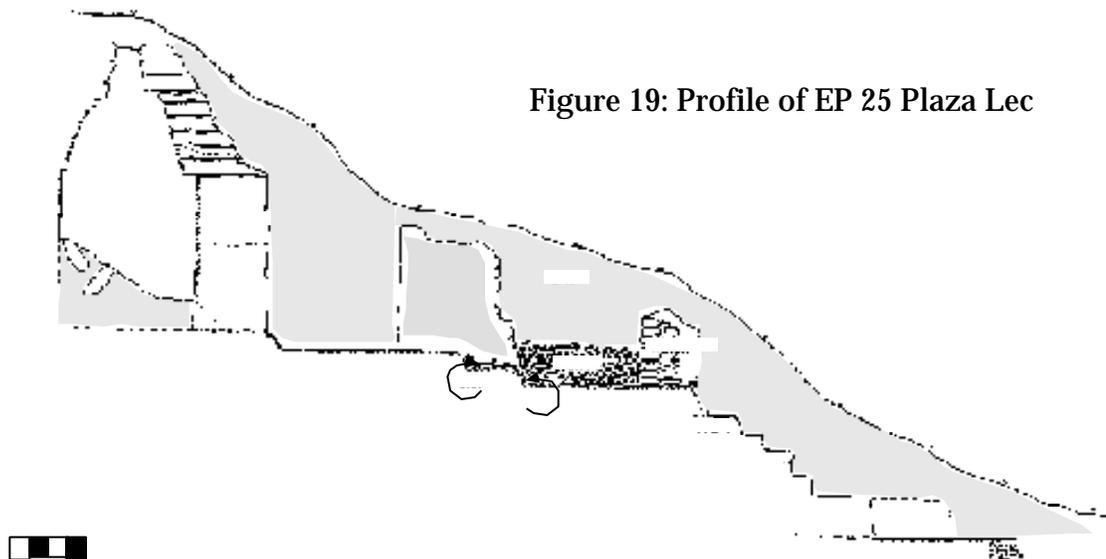
Figure 19: Profile of EP 25 Plaza Lec

The consolidation of the Xamanaj Temple is based on the excavation of EP25 that revealed a three room corbel vaulted temple building representing the northern most extension of the monumental site core of El Pilar (Fig. 19). Facing the open Plaza Lec, the two front rooms have long since collapsed, but the third, rear room retained a large section of vaulted ceiling intact. Unfortunately, looters had entered this room through the center of a vault wall and had greatly weakened the structure as well as exposed a large portion of the building to the debilitating effects of the weather. While a part of this third vault had recently collapsed, a large portion remained precariously in place. The object was to stabilize this vault.

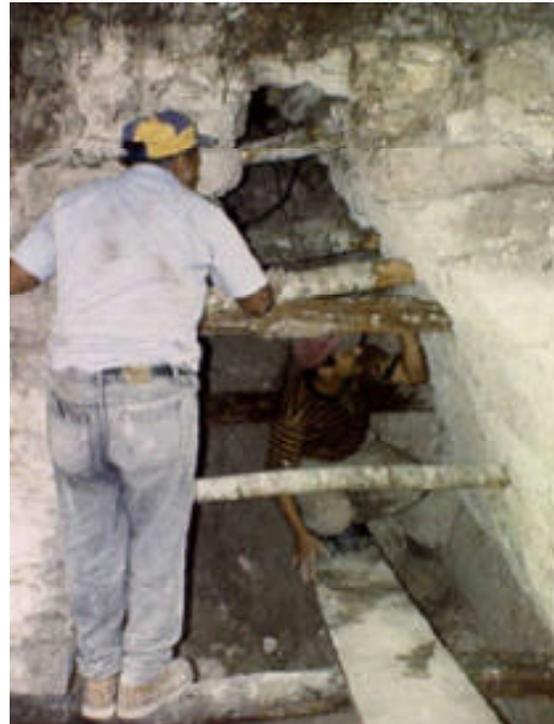
Figure 20: Consolidation at EP 25

A 4 x 3 meter area, just to the south of the looters trench and adjacent to the western wall of the rear room, was carefully cleared of humus to expose the remaining vault stones *in situ*. Most of the roof and upper core had deteriorated down to the vault core leaving vault stones and portions of the vault mass exposed on the sides. This exposure revealed a finished plaster construction sealing surface above the vault. Roof debris were cleared to the capstones so that a careful consolidation assessment could be made.

At this point a number of the capstones were carefully removed and set aside and a portion of the wall most affected by the looters was disassembled. Many of the stones, though found *in situ*, were badly damaged and suitably sized replacements were found as substitutes. The stones at the wall top that formed the spring of the arch, for instance, were found to be massive stones approximately 80 cm wide, 40 cm thick and almost 1.5 meters long. Each exposed vault spring stone revealed structural problems. Most were cracked down the middle from the enormous stresses placed on them by the vault mass and roof weight. To date we have not located a large supply of suitable new stone this size, consequently two stones were used in place of the original single one.
